Sun SPARC Enterprise® T5120 and T5220 Servers

Product Notes

Part No. 820-2176-22
March 2010, Revision A

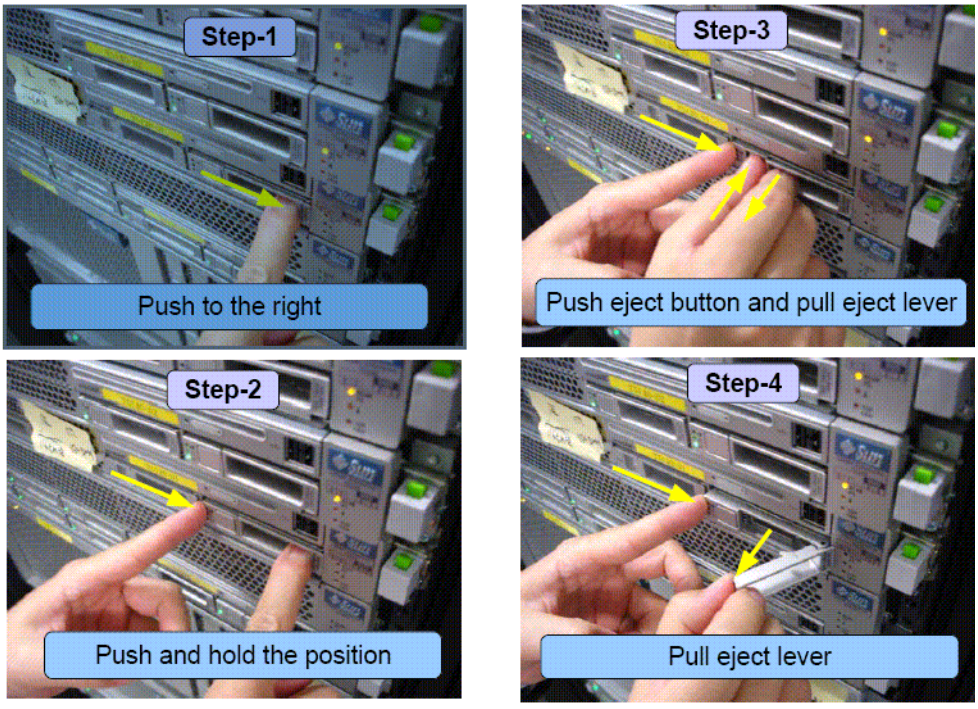
Hard Drives Can Be Difficult to Remove From Right-Side Drive Bays

Hard drives in the right-side drive bays can be difficult to remove.

Workaround: Until a mechanical fix is implemented, use the following procedure to remove hard drives from right-side drive bays.

1. Press the drive to the right.

2. Push in on the drive, while holding it pressed to the right.

3. Press the drive eject button and pull on the eject lever.

4. Use the eject lever to slide the drive out of the bay.
